# **DEVELOPMENT OF STATE-SPECIFIC GUIDELINES AND MODEL DESIGN FOR SCHOOLS**

## **FINAL REPORT**

**DEPARTMENT OF CIVIL ENGINEERING  
NATIONAL INSTITUTE OF TECHNOLOGY HAMIRPUR  
HAMIRPUR – 177 005**

**JANUARY 2016**

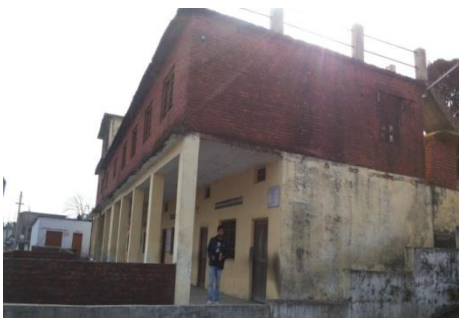
Fig.9 Mass irregularity(GSSS Chabutra)

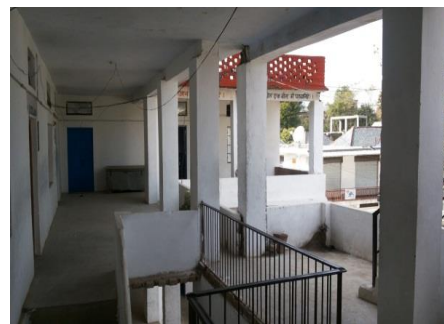
Fig.10 Chaotic construction (GSSS kot)

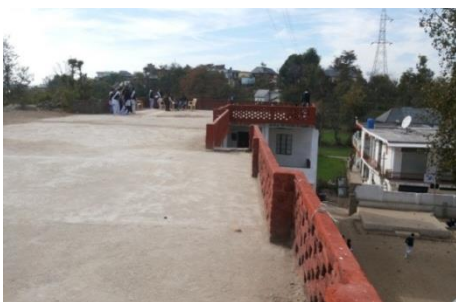
Fig.11 Irregular plan(GSSS kot)

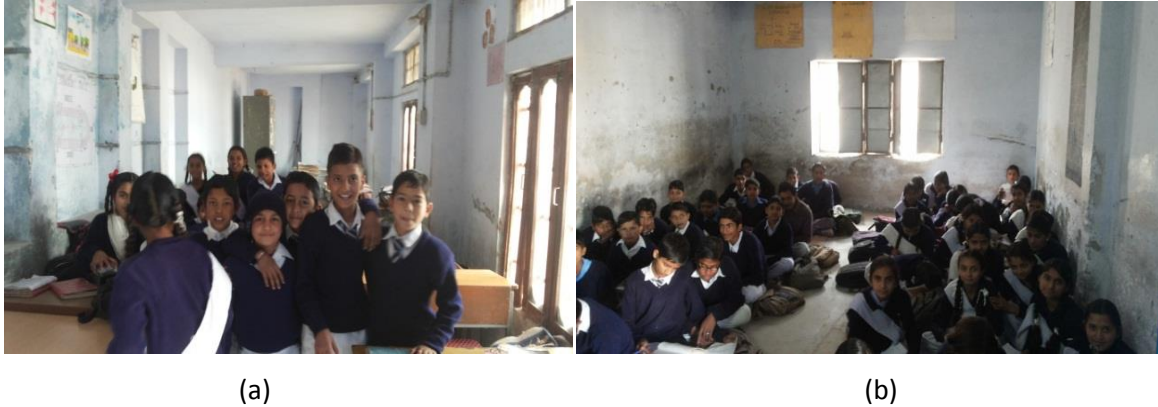
- ❖ In some of the cases the length to breadth maximum ratio surpassed and hence the size of the classroom are not in accordance with the space allocation as Indian Standards. Apart from the aspect ratio it is found that in most of the schools the circulation area i.e. corridors exceeded the limit provided by the standards.

Fig.20 (a) and (b) are example of incorrect aspect ratio design( GHS kot)

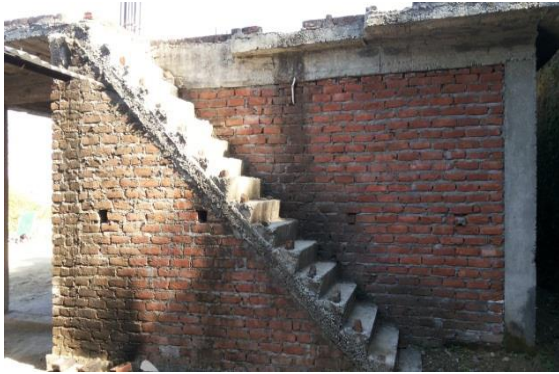
- ❖ Most common problem founded with the schools is the problem of stampede due to the stairs. The staircases are constructed in open area which make them inconvenient to use during raining season. The size of stairs, width of staircase, height of handrail was not as per the standards.

Fig.25 Open stairs not as per standards (GPS Pananyala)

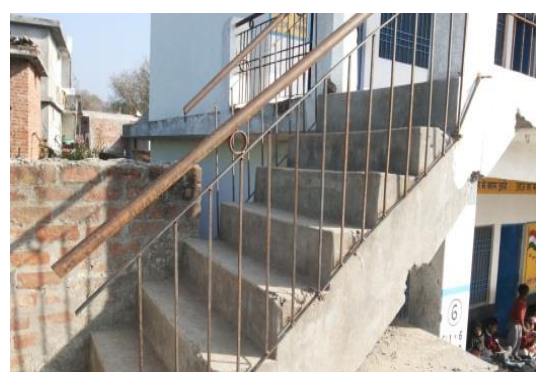
Fig.28 Improper finishing of handrail (GSSS Tal)

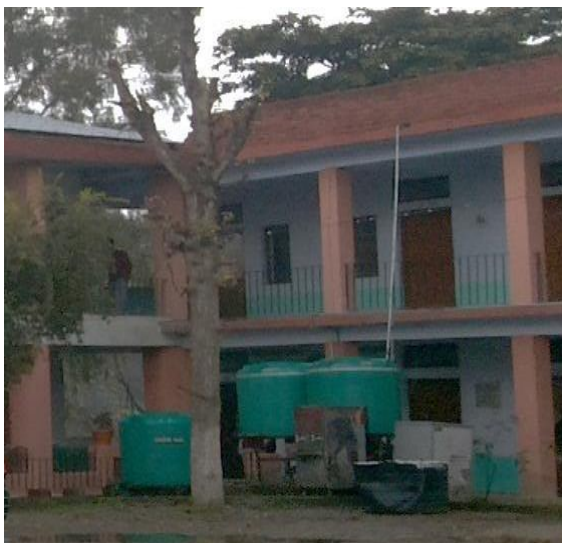
Fig.33 Incorrect setup of rain water harvesting plant (GSSS Nalti)

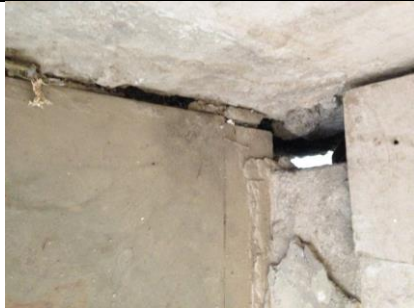
| Sl. no. | Walls and Exterior | Incorrect Practice | Correct Practice |
|---|---|---|---|
| 2. | | Faulty infill wall construction | In RCC framed structure, the infill walls must be properly finished with proper allowance. |

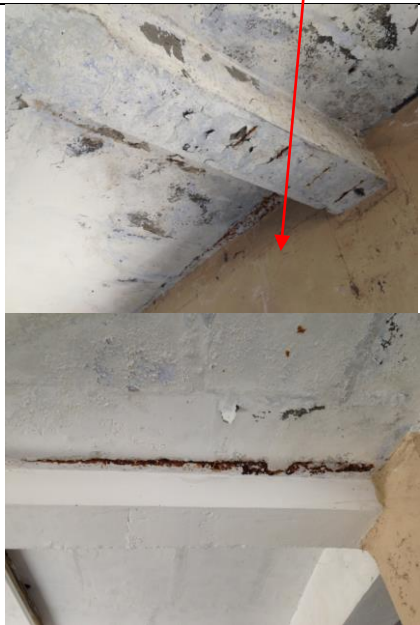
| Sl. no. | Walls and Exterior | Incorrect Practice | Correct Practice |
|---|---|---|---|
| 3. | | Reinforcement corrosion in the beams. This is owing to inadequate concrete cover and the concrete being porous. | Porosity in concrete must be addressed in the construction stage. |

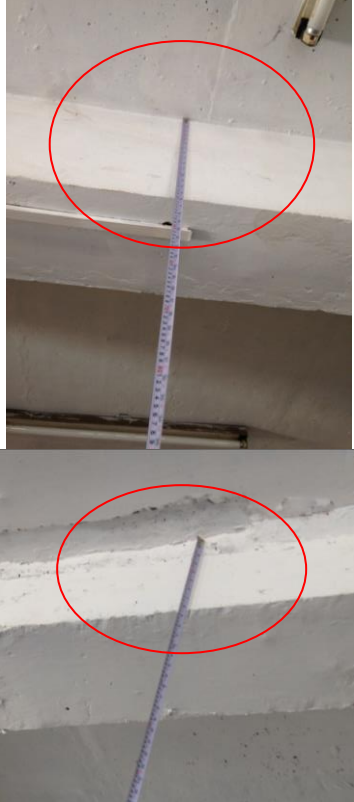
| 4. | | Depth of beam is different at different locations along the span. It may be due to fault in shuttering and poor workmanship | Scaffolding must be placed properly and a strict check on the workmanship is necessary. |

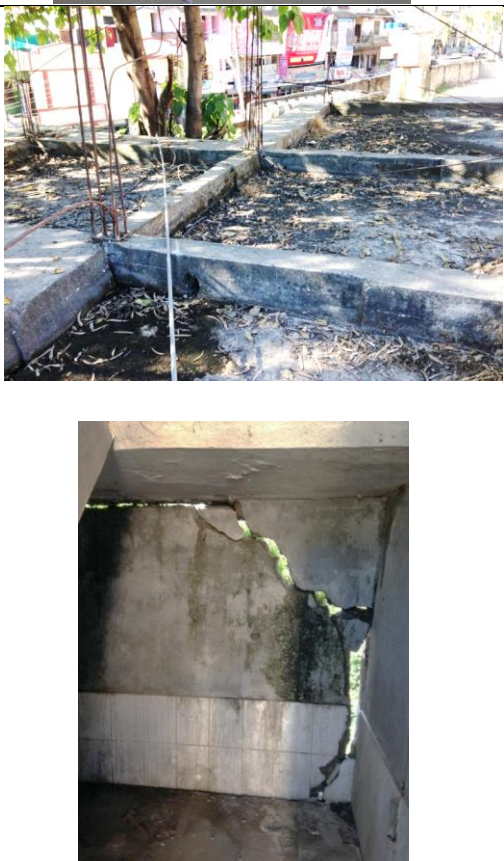
| 5. | | Inverted beams in the roof slab with improper drainage lead to accumulation of water. The effects of dampness are visible | Whenever inverted beam slab construction is taken up, care must be taken to provide a proper roofing or efficient drainage |

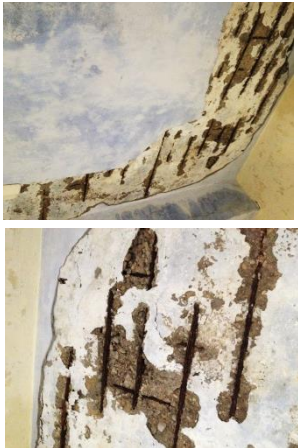
| 7. | | Reinforcement corrosion in case of a slab of the building. It may be due to porosity of the concrete or inadequate cover to the slab | The shuttering and workmanship requires supervision to ensure proper cover and good non-porous concrete mix |

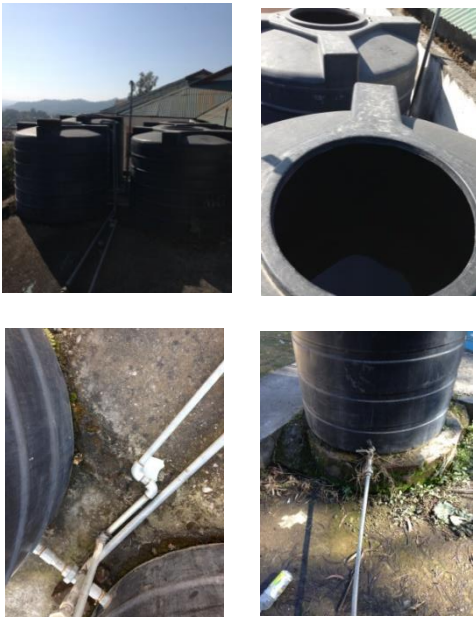
| NON STRUCTURAL ELEMENTS | | Incorrect Practice | Correct Practice |
|---|--|---|---|
| | | The lids of water tanks are not provided. The water often overflows causing dampness on the roof slab | Thee lids of water tanks must be securely in place. Float valve must be used to prevent overflow |

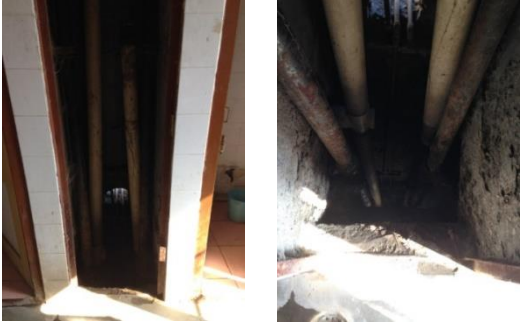
| | <p>Service ducts in the student washrooms are left open. This poses a great hazard for all the occupants of the building.</p> | <p>Service ducts must be safely closed with proper door shutters and locked to prevent any mishap</p> |
