**KOTROPI LANDSLIDE, MANDI DISTRICT, HIMACHAL PRADESH**

**(A Preliminary report)**

**National Remote Sensing Centre/ISRO, Hyderabad**

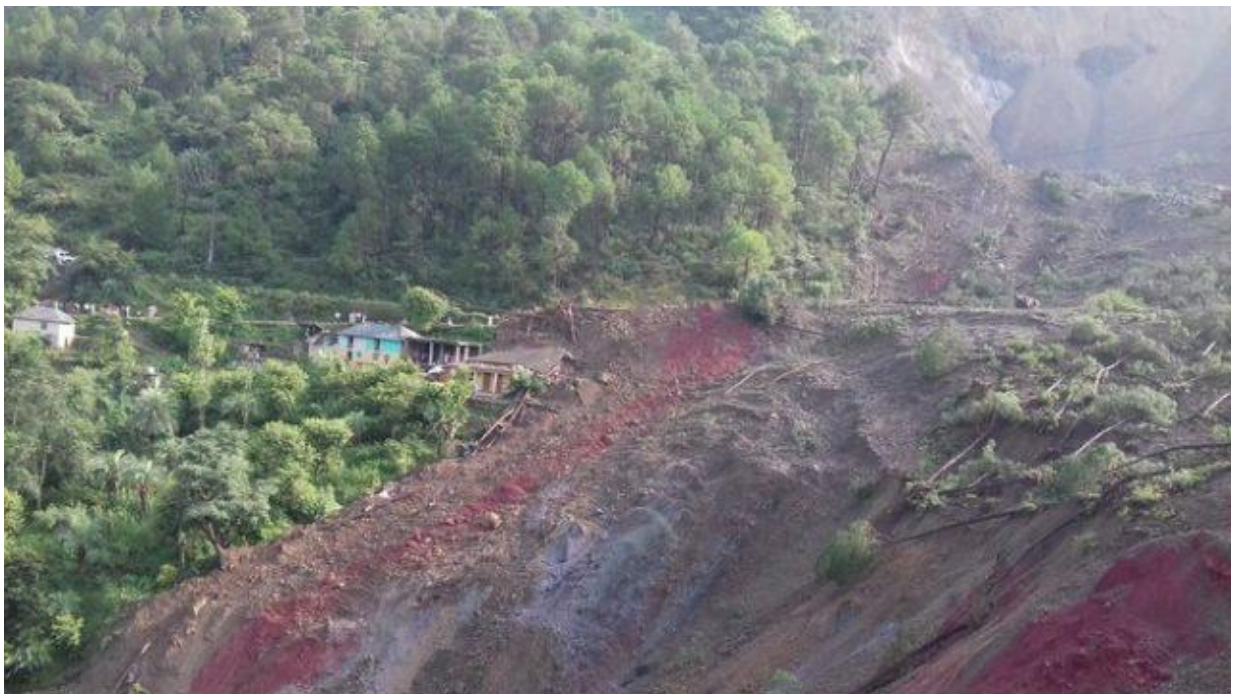
Figure 1: Kotropi landslide (Source: News World India)

**2. Background:** A massive landslide occurred near the village of Kotropi, (near Kotropi Bus Stop), in Mandi District of Himachal Pradesh, on Sunday, 13th of August, 2017. The landslide occurred on National Highway 154, the road between Mandi and Pathankot (figure 1). Media reports suggest that a section of the slope collapsed totally and two buses of Himachal State Transport along with few other vehicles were buried under the debris. As of now, news reports suggest that there has been 47 fatalities from the incident. Around 300 m of the highway has been completely buried under debris, thus cutting of communication on a very important road.

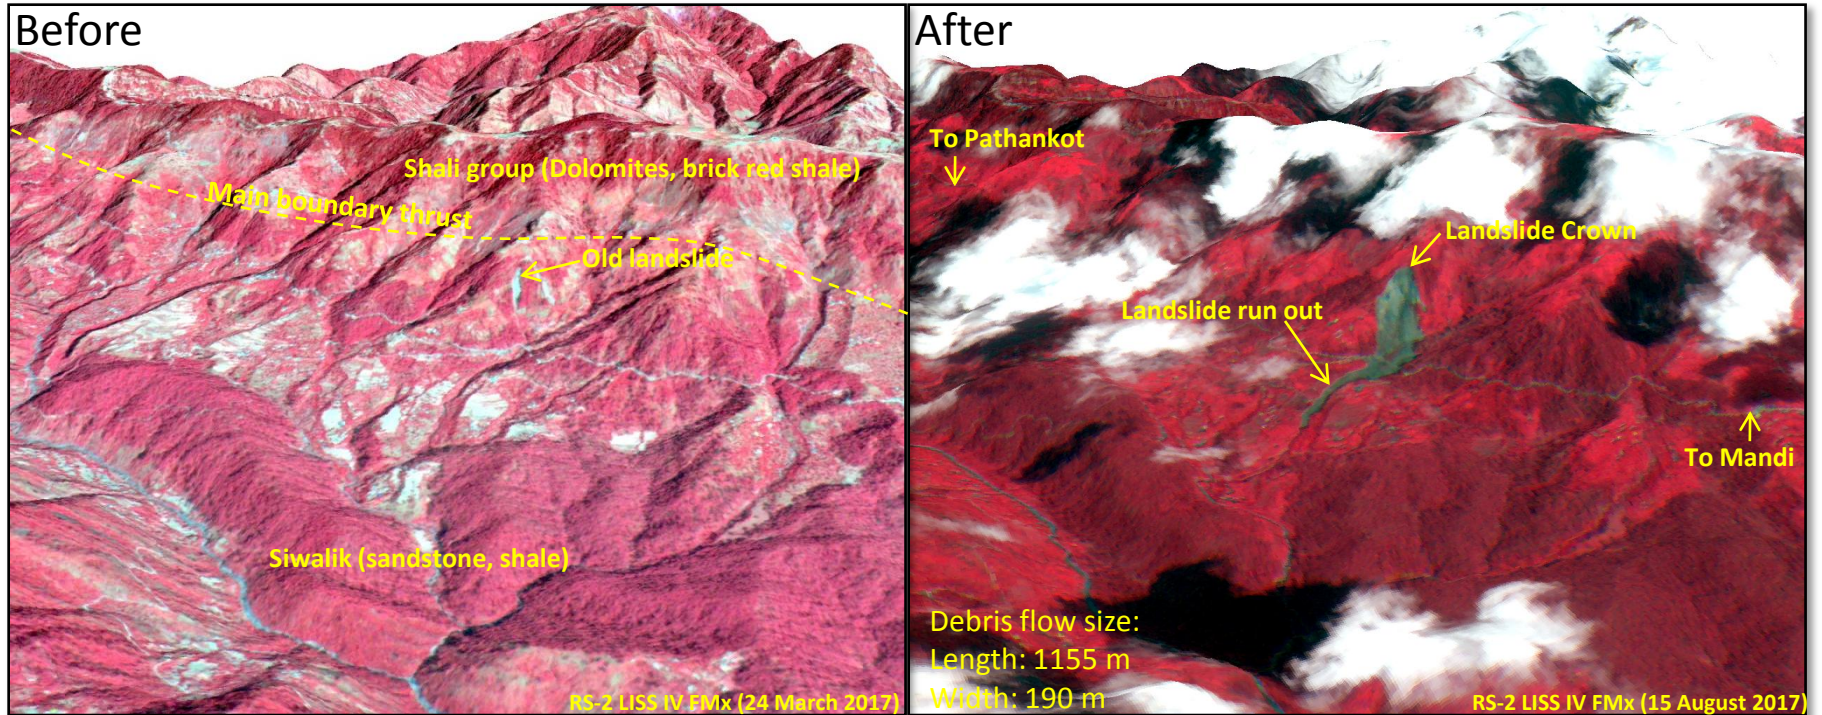
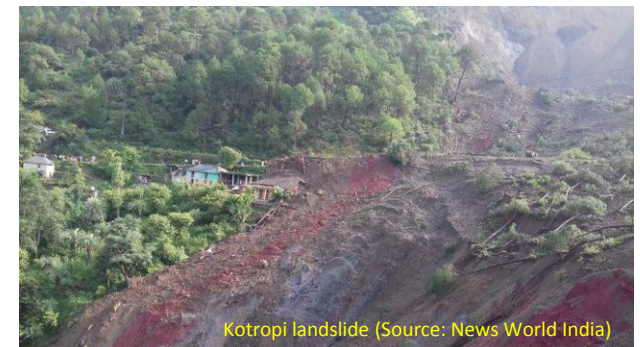
## Kotropi landslide (13 Aug 2017) – A 3D perspective view (LISS IV FMx with 10 m CartoDEM)
