# Report on Geological and Bathymetry survey of glacial lake at Baspa Upstream of Sangla [Lake ID - NDMAo81]

07.09.2024 TO 10.07.2024

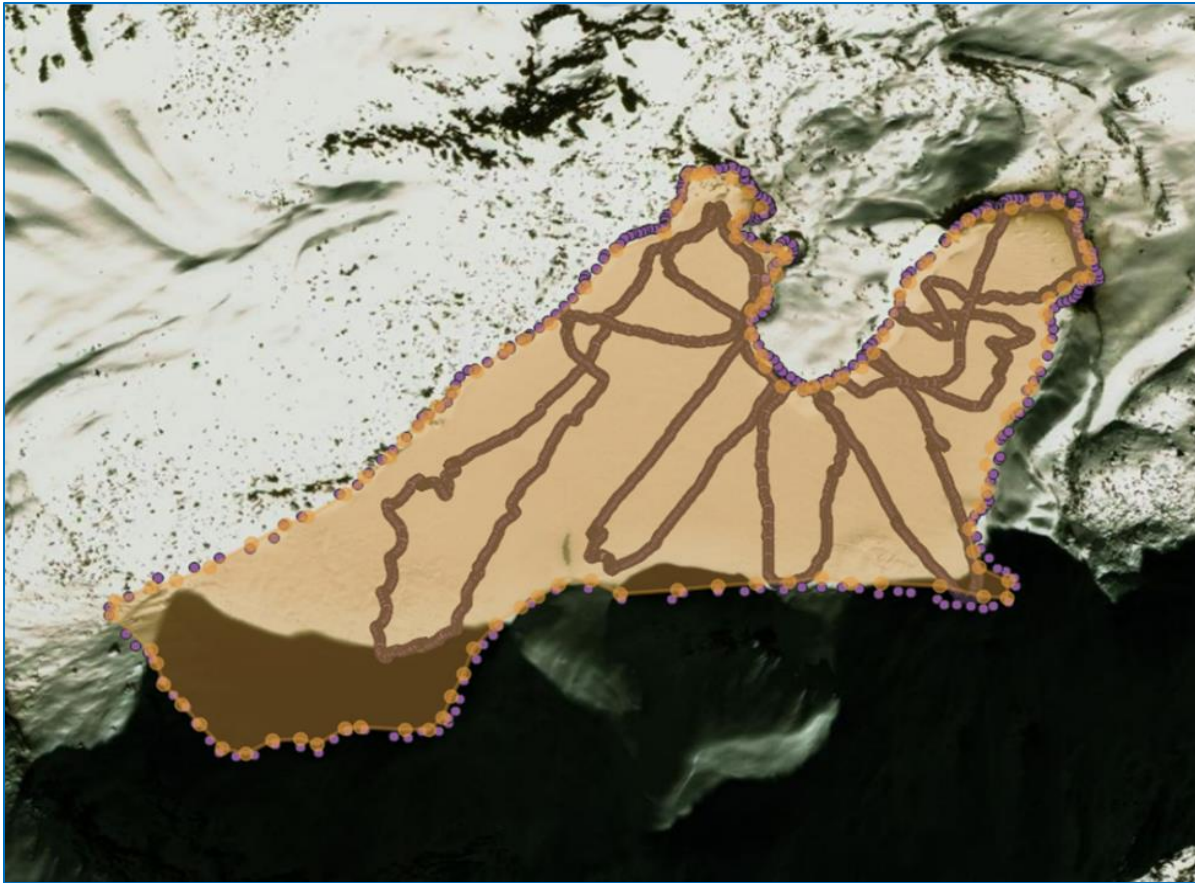
Due to the short window period and adverse weather conditions that prevailed at Lake Face, the survey was conducted haphazardly, covering almost the entire lake area. Using the survey data, depth values were interpolated to fill out the non-surveyed regions of the lake. Therefore, the lake's boundary had to be manually marked using the base map as given in Fig 2, and the data thus created has been utilized to automatically generate the envelope of the lake body. Drone images were captured of the entire lake to assist with this activity.

**Fig 2. Manually marked lake boundary**

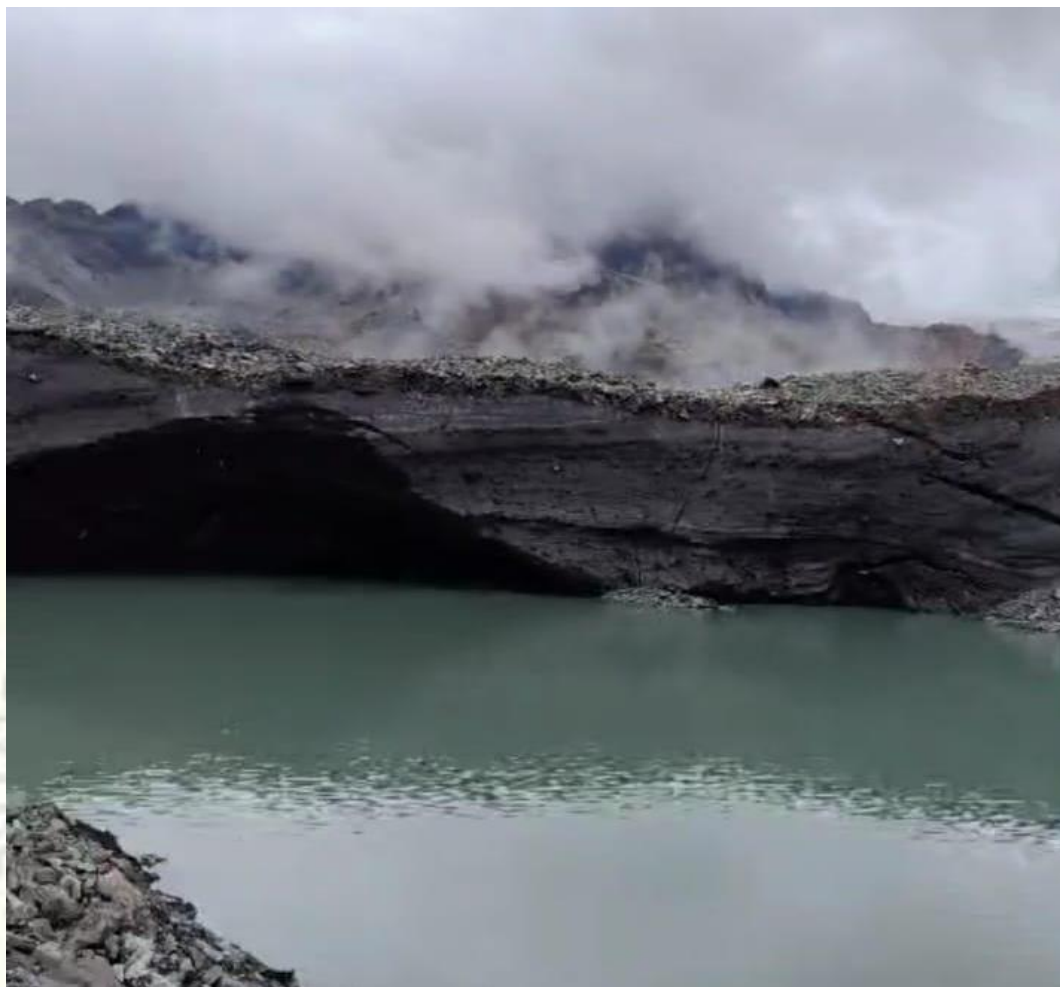
Fig 3: The moraine dam wall in August 2024

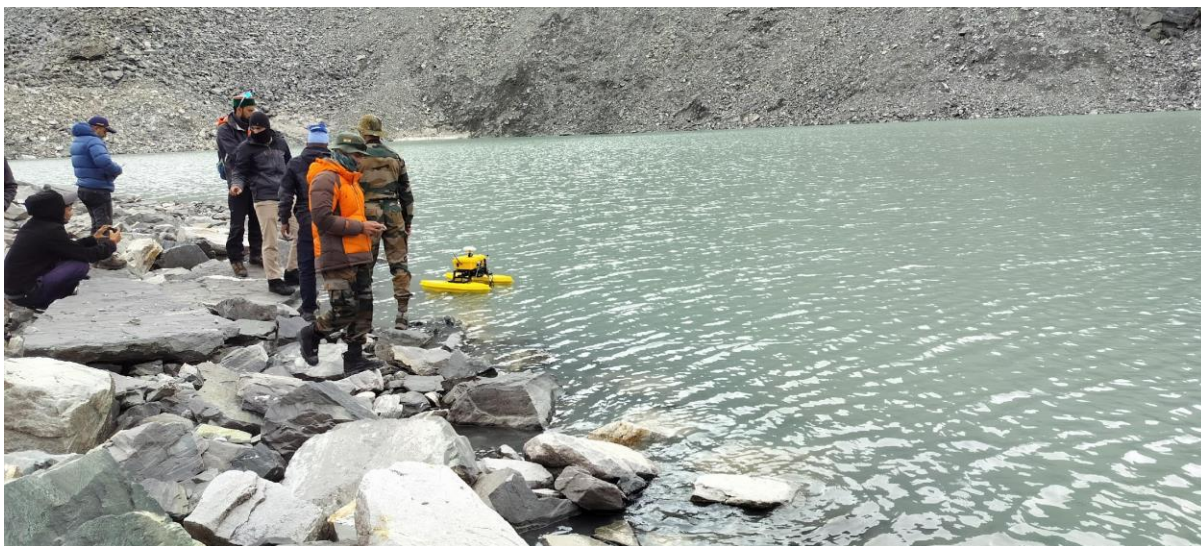
ABSV survey starting on the lake
