# Report on Geological and Bathymetry Survey of Vasuki Glacial Lake [Lake ID – NDMAo77]

07.10.2024 TO 16.10.2024

*REPORT ON SURVEY CONDUCTED AT VASUKI LAKE, HP*

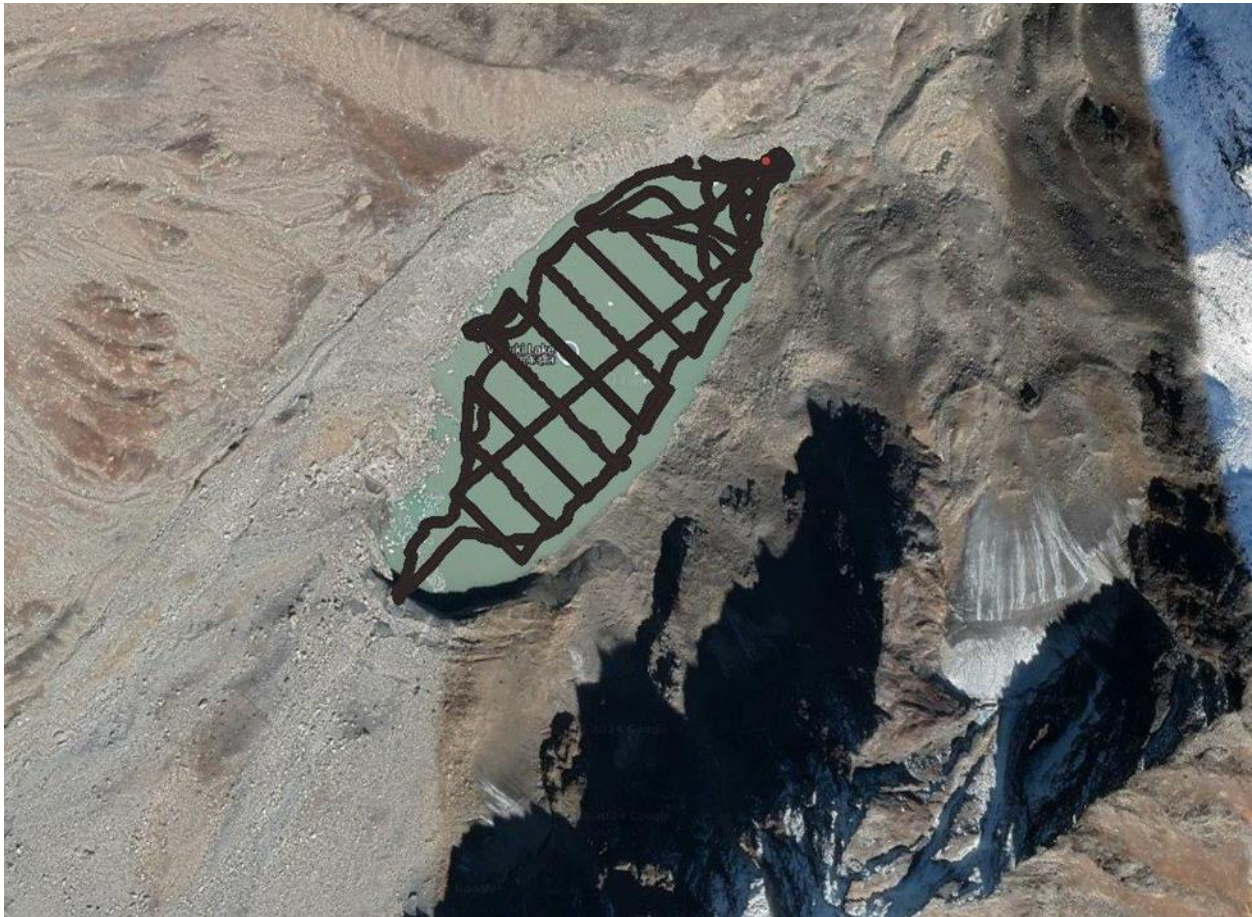
**Fig 3. Survey data plotted in the background of Vasuki lake**

To carry out the above-mentioned functions, a high-resolution DEM corresponding to the location of the lake is required. C-DAC(T) has requested the Space Application Centre (SAC) to obtain a high-resolution DEM of the region of interest, which is yet to be received. In the interim report, a low-resolution DEM collected from 'USGS Earth Explorer', which is available for public use, has been utilized in the AGLPS for data processing.

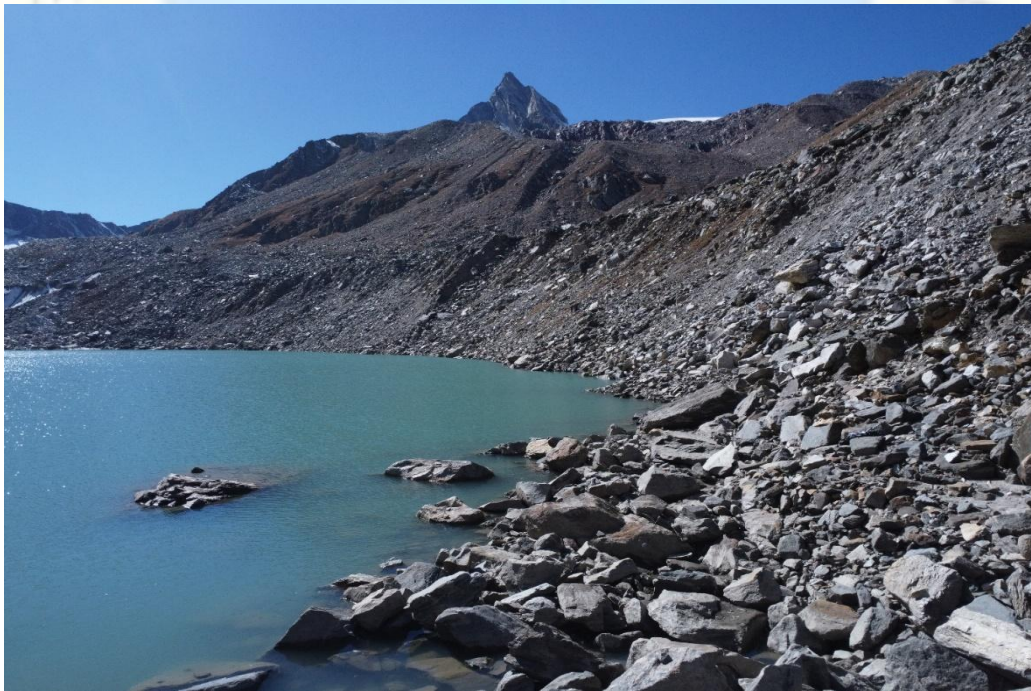
Figure 10: Moraine
