# **DEVELOPMENT OF STATE-SPECIFIC GUIDELINES AND MODEL DESIGN FOR SCHOOLS**

## **FINAL REPORT**

**DEPARTMENT OF CIVIL ENGINEERING  
NATIONAL INSTITUTE OF TECHNOLOGY HAMIRPUR  
HAMIRPUR – 177 005**

**JANUARY 2016**

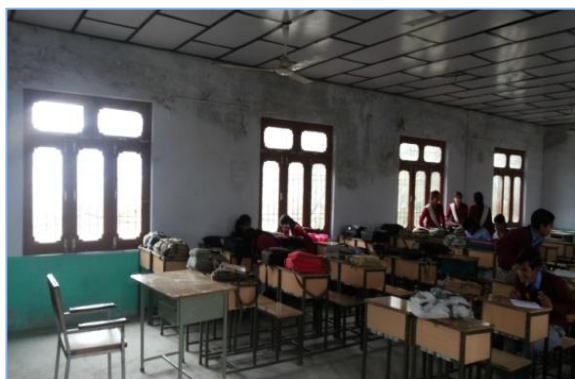
Fig. 1 Poor design-wall length > 8m ( GSSSI Nalti)

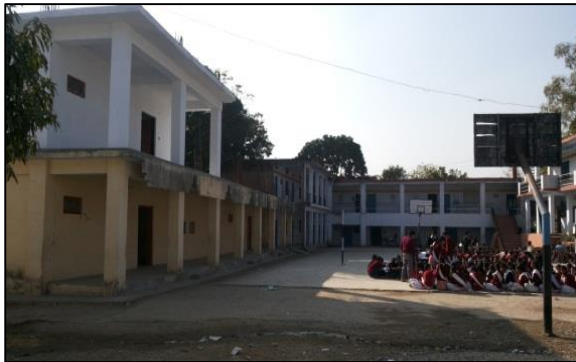
Fig.5 Vertical irregularity

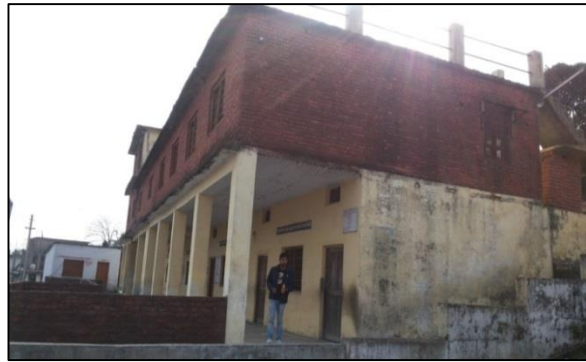
Fig.6 Mass irregularity

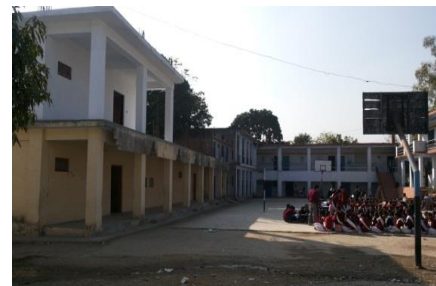
- ❖ In some schools the vertical, plan as well as mass irregularities are found. These irregularities are the main cause of destruction during natural hazards.

Fig.12 Vertical and plan irregularity(GSSS Tal)

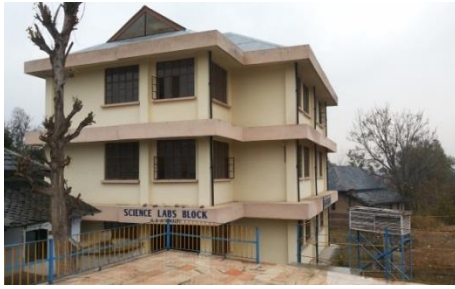
Fig.13 Irregular plan (GSSS Nalti)

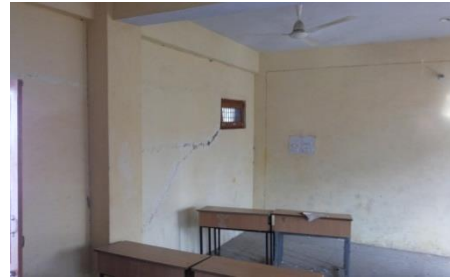
- ❖ In some places it is founded that the location of the openings are not as per standards IS 4326:1993.

Fig.14 Incorrect ventilator placement (GSSS Tal)

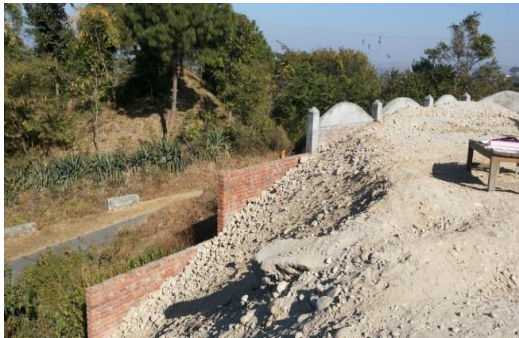
Fig.15 Inappropriate construction practice boundry wall acting as retaining wall

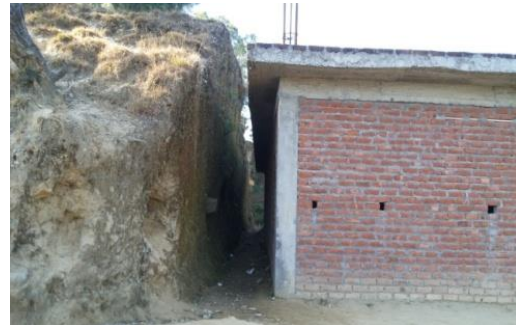
Fig.16 inappropriate distance between cut slope and building wall (GPS Panyala)

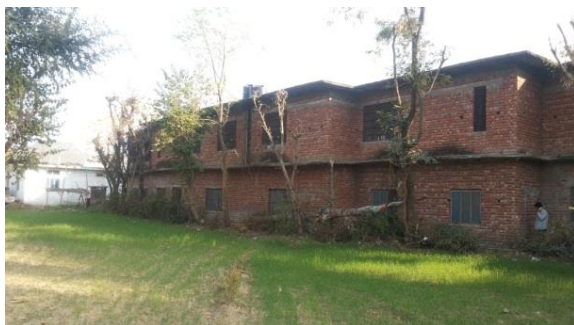
Fig. 17 Irregular wall pattern responsible for Increased wind speeds. (GSSS Tal)

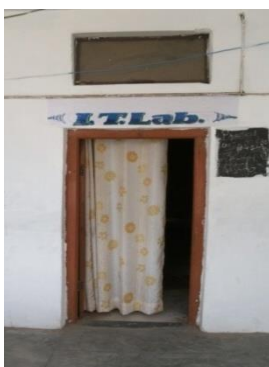
- ❖ Most of the sizes of exits are inappropriate as they do not meet the criteria of min. width 100 cms and height 200 cms.

Fig.18 Size not met with standards(GSSS Kot)

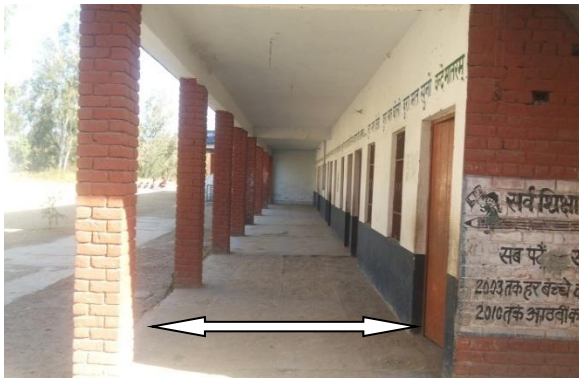
- ❖ In some of the cases the length to breadth maximum ratio surpassed and hence the size of the classroom are not in accordance with the space allocation as Indian Standards. Apart from the aspect ratio it is found that in most of the schools the circulation area i.e. corridors exceeded the limit provided by the standards.

Fig.21 Corridor area limit exceeded (GSSS Bhota)

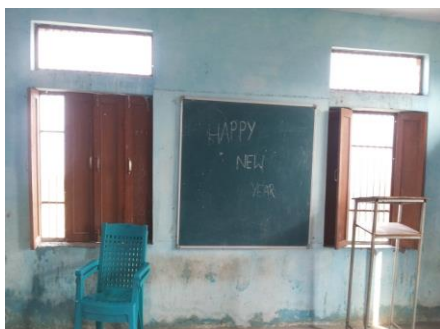
Fig.23 Wrong placement of greenboard causing glare.(GHS Bralhari)

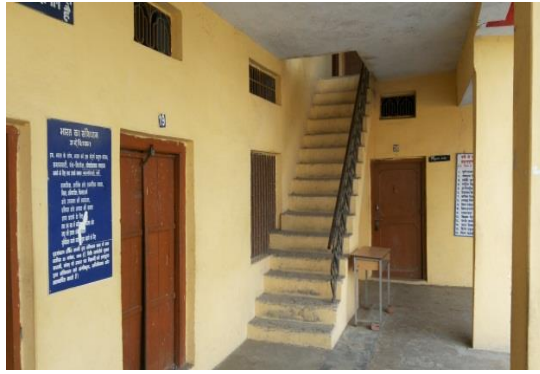
- ❖ Most common problem founded with the schools is the problem of stampede due to the stairs. The staircases are constructed in open area which make them inconvenient to use during raining season. The size of stairs, width of staircase, height of handrail was not as per the standards.

Fig.26 Number of stairs present exceeds max. limit per flight.(GSSS Chabutra)

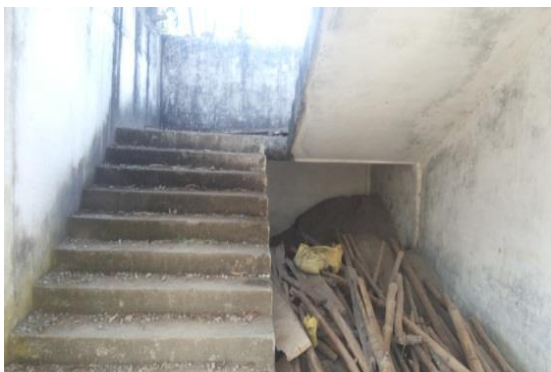
Fig.27 Handrail not installed.(GSSS Bhota)

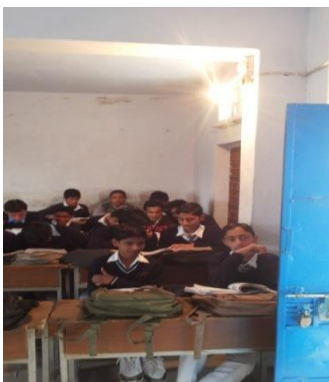
Fig.29 Inappropriate artificial illumination (GPS Dundana)

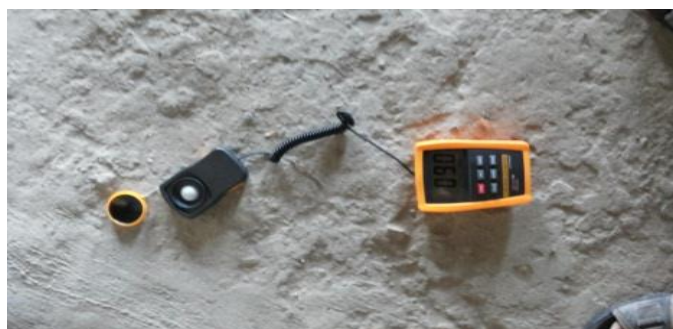
Fig.30 luxmeter indicating 90 lux an insufficient illumination(GSSS Kot)

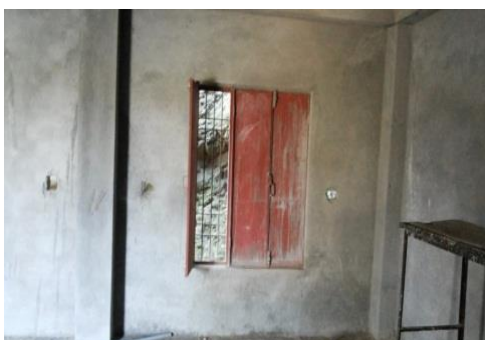
Fig.31 Steel windows inappropriate for illumination Requirement (GPS Panyala)

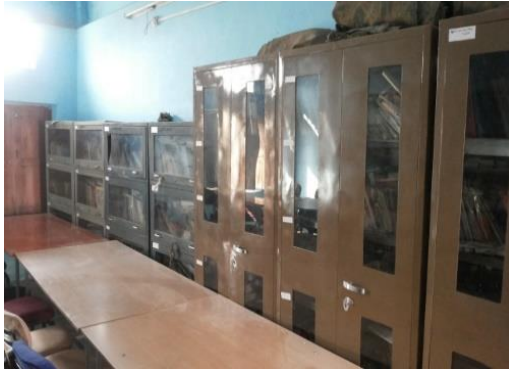
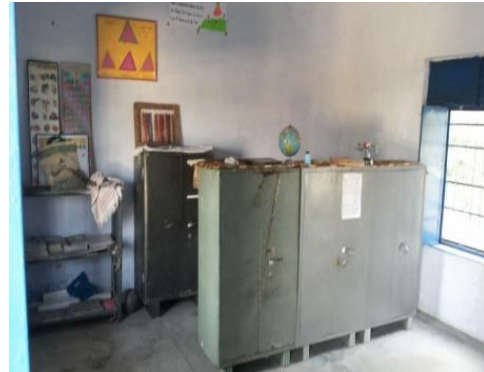
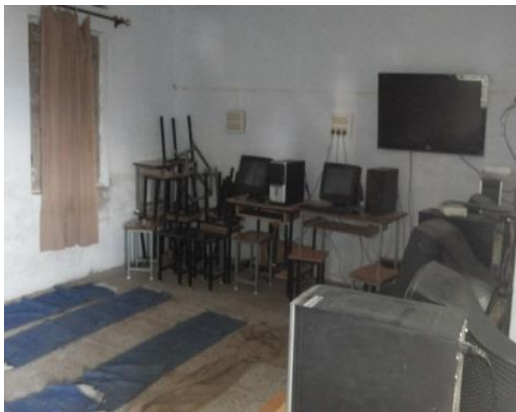
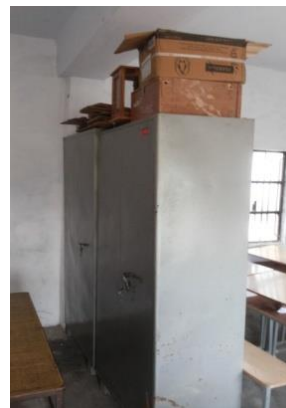
❖ The non structural components should be checked for adequate fixtures and anchorage.

Fig.32 (a) improper placement of bookshelves makes it difficult to operate (GSSS Chabutra) (b) Unanchored Almirah (GPS Panyala) (c) Unanchored computer equipments (GSSS kot) (d) Unanchored Almirah placed in classroom (GSSS kot)

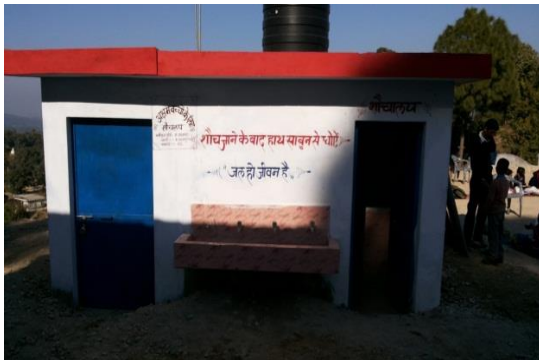
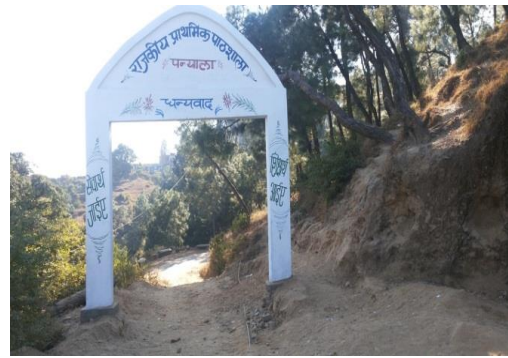
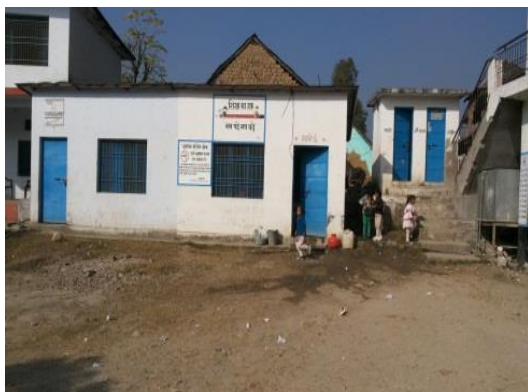
Fig.34 (a) Unhygienic provision for drinking water (govt school Panyala) (b) Inaccessible approach to school (govt school Panyala) (c) Toilets are inaccessible to physically retards (GSSS Tal)

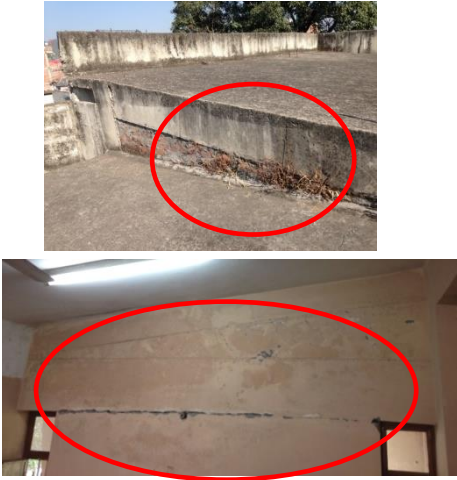
| Sl. no. | Walls and Exterior | Incorrect Practice | Correct Practice |
|---|---|---|---|
| 1. | | The roof slab is not treated for waterproofing. Moreover the brick infill has not been plastered leading to dampness. | Proper plaster and waterproofing treatment must be given to roof slab to avoid the problem of dampness. |

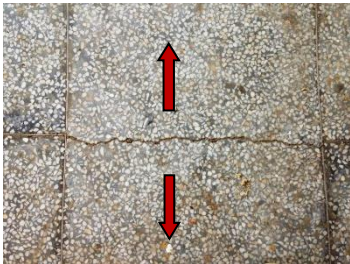
| 8. | | Differential settlement at the ground floor level has caused the floor to crack | The ground must be prepared properly during laying the foundation to ensure the plinth and floor do not suffer from settlement |

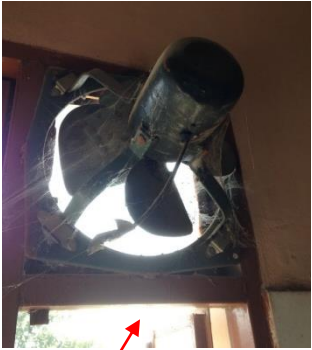
| <p><b>Fixed Glass</b></p> | <p>The exhaust fan is simply fitted for formality sake over an existing glass ventilator.</p> | <p>Before fitting the exhaust fan, it is necessary that the glass behind must be removed</p> |

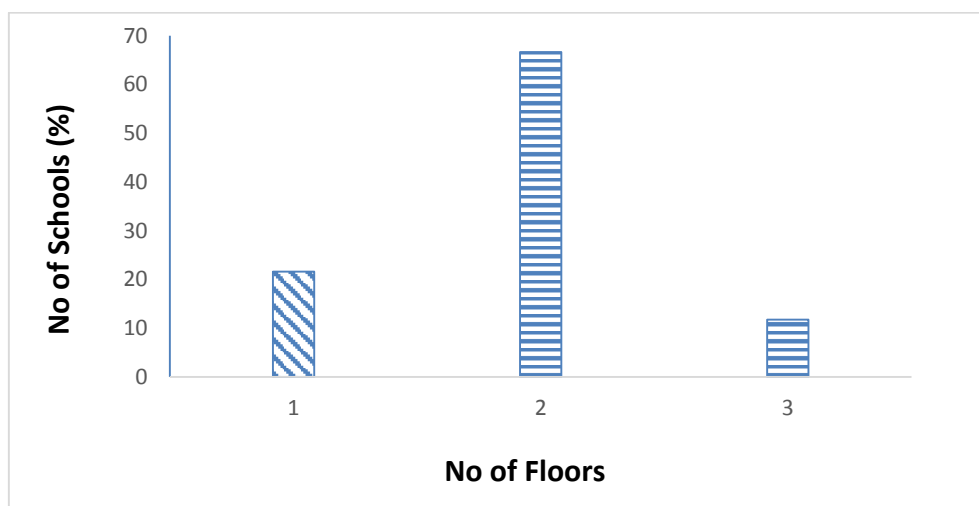
Fig. 16.1 : School building blocks with different number of floors

The schools have been surveyed for the building blocks constructed with different number of floors. It was found the maximum of building blocks (approx. 70%) are constructed upto two storeys, with 20% building having one storey and a few (approx. 10%) buildings having three storeys. Thus some building blocks are under-utilized.

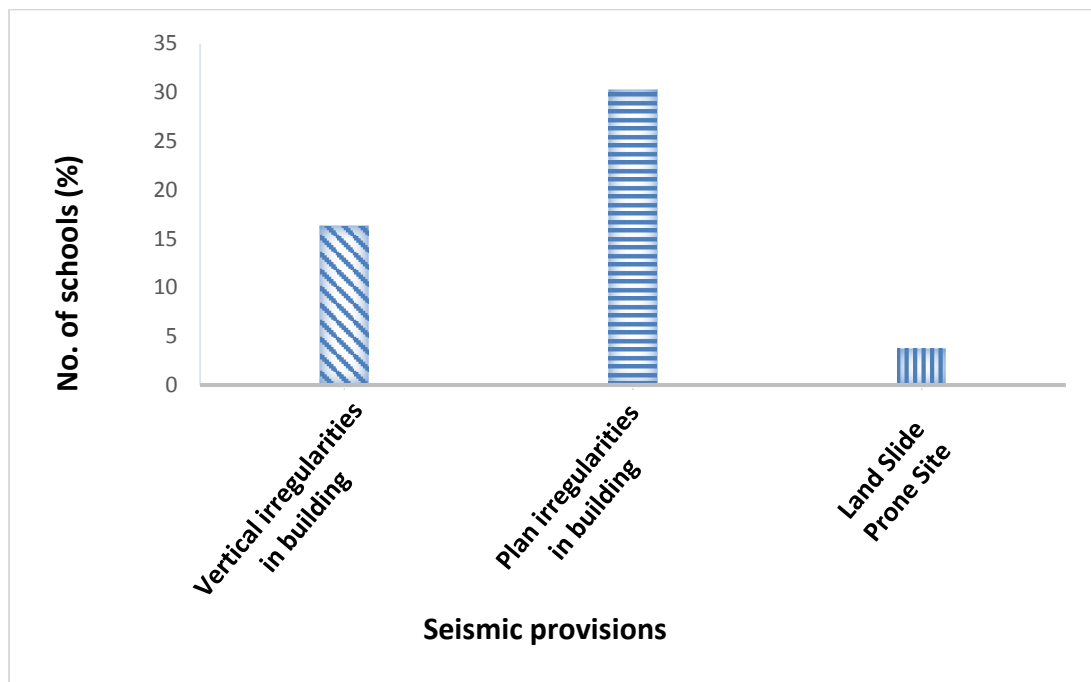
As major part of Himachal Pradesh belongs to seismic zone V, the buildings were checked for seismic provisions. It was found that buildings have plan and vertical irregularities. Any expansion of the building blocks should be carried out in a manner that decreases and not increase the irregularity.

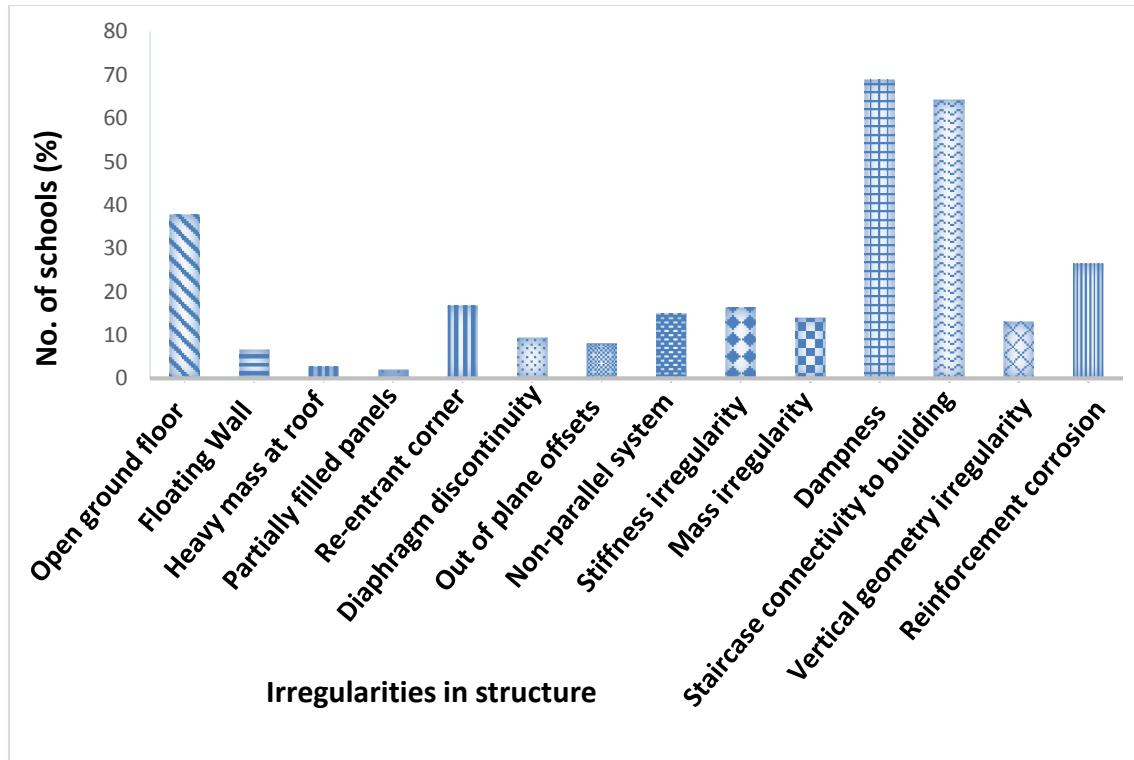
This part of survey was carried out to find out the various irregularities and other parameters which affect the behaviour of school building blocks during earthquake. It was found that dampness, staircase connectivity to building, open ground floor and reinforcement corrosion are the major problems. The dampness could be countered with the provision of the damp-proof course in masonry as a correct construction practice. The open ground floor construction can be avoided by constructing the first floor masonry wall only above the masonry walls of the ground floor. The corrosion of reinforcement can be avoided by following good construction practice.

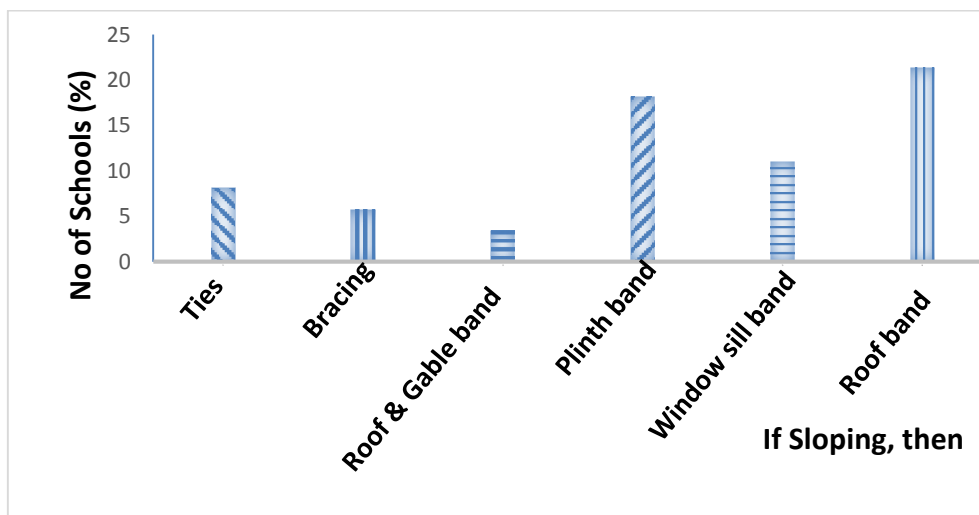
As per IS 4326:1993, provision of band for improving the earthquake resistance of the building is described. It was observed that the school building blocks are highly deficient with respect to the provision of earthquake resistant bands. The provision of earthquake resistant features can only be ensured with effective sensitization of construction workers towards hazard resistant conception.

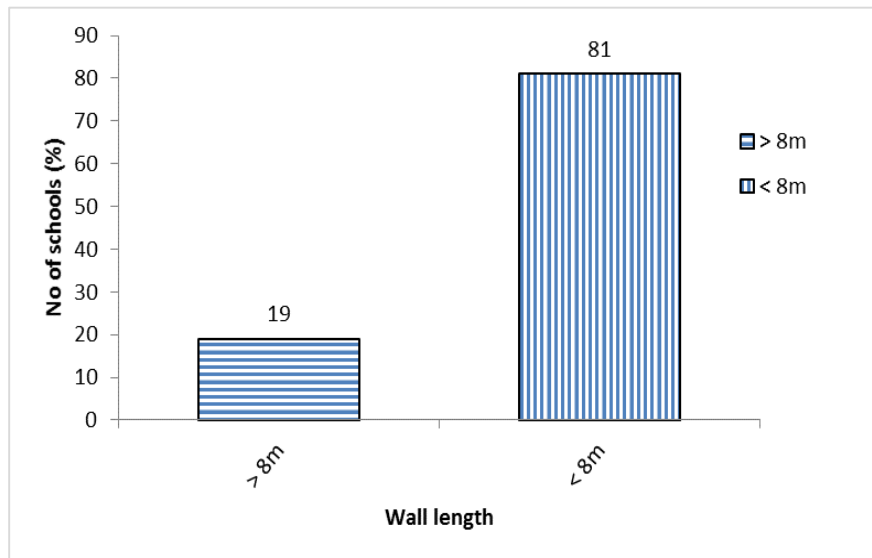
The out-of-plane failure probability for the wall longer than 8 meter is very high. Hence the maximum length of wall in school buildings were considered for study. It has been found that 20% of buildings have walls of length more than 8m. This is mainly due to some portion of the building blocks are used as hall for assembly purposes.

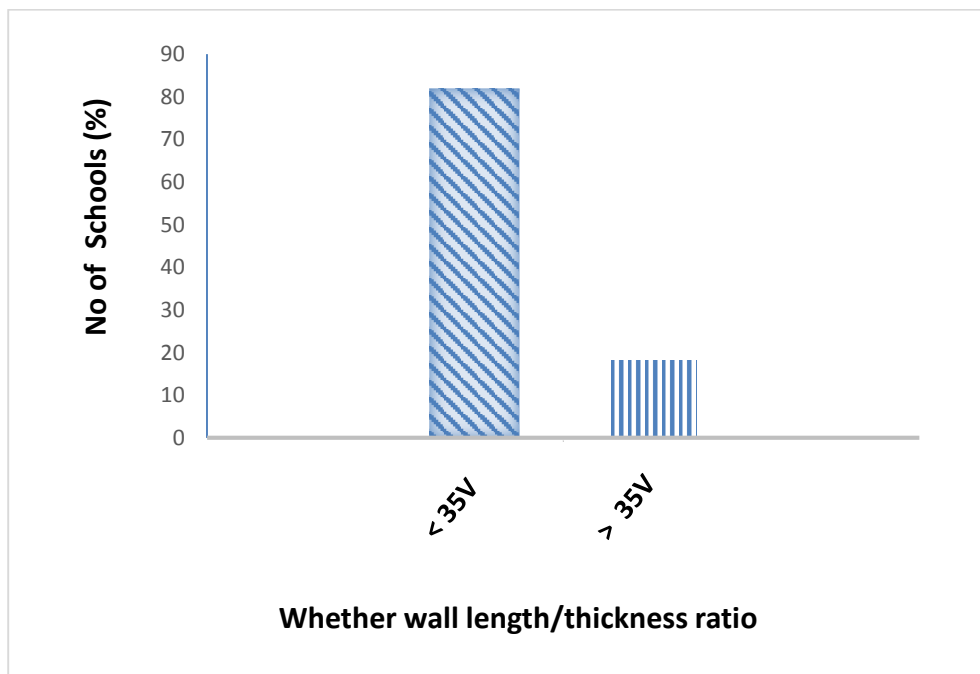
The wall with greater slenderness ratio has a higher tendency towards out-of-plane failure. Hence the wall height/thickness ratio was checked against a benchmark of 35 as specified in IS 13935:2009. In this survey, 20% of the buildings were found having higher slenderness ratio. This is due to the fact that the buildings are constructed of half-brick instead of one brick thickness.

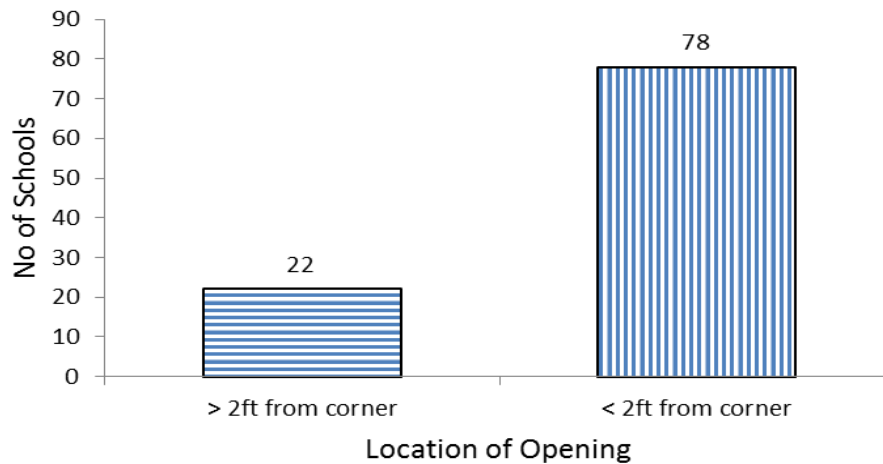
As corners of the non-engineered buildings get affected during earthquakes, hence providing openings near the corners becomes major parameter in deciding the building's behaviour in earthquake. Hence location of openings were surveyed and they were categorized against a safe distance of 2' from corner as per IS 4326:1993. It was found that approximately every 3 out of 4 buildings have openings at less than 2' from corner, whereas only one-fourth buildings have the opposite, i.e. only those one-fourth buildings are safer than the rest.

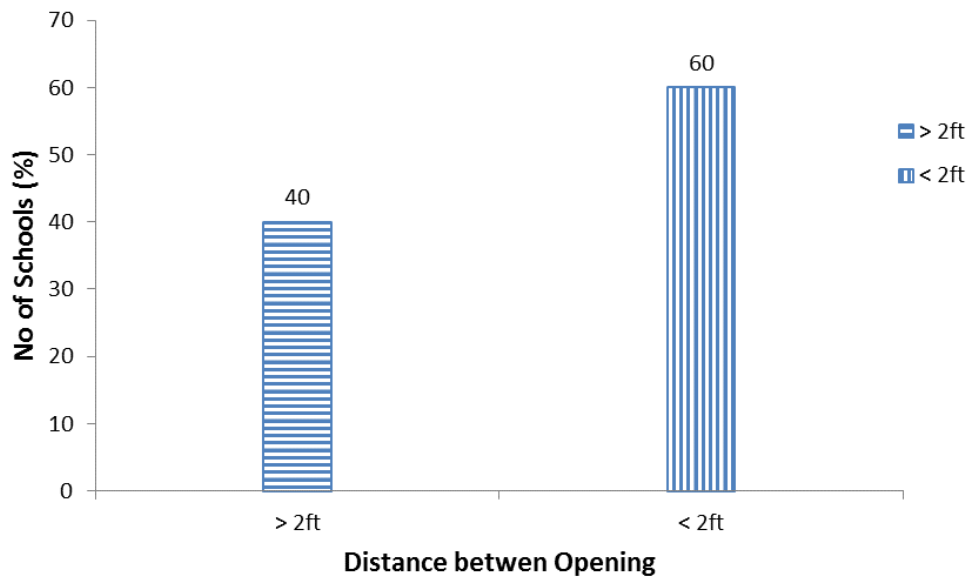
The distance between openings in the school buildings were surveyed and categorized against a safe distance of 2' as per IS 4326:1993. It was found from the survey that about 40% of the buildings have openings at distance less than 2' and rest (60%) have openings spaced at more than 2', which leads us to the conclusion that the brick piers between the openings will be subjected to the shear failure in case of an earthquake.

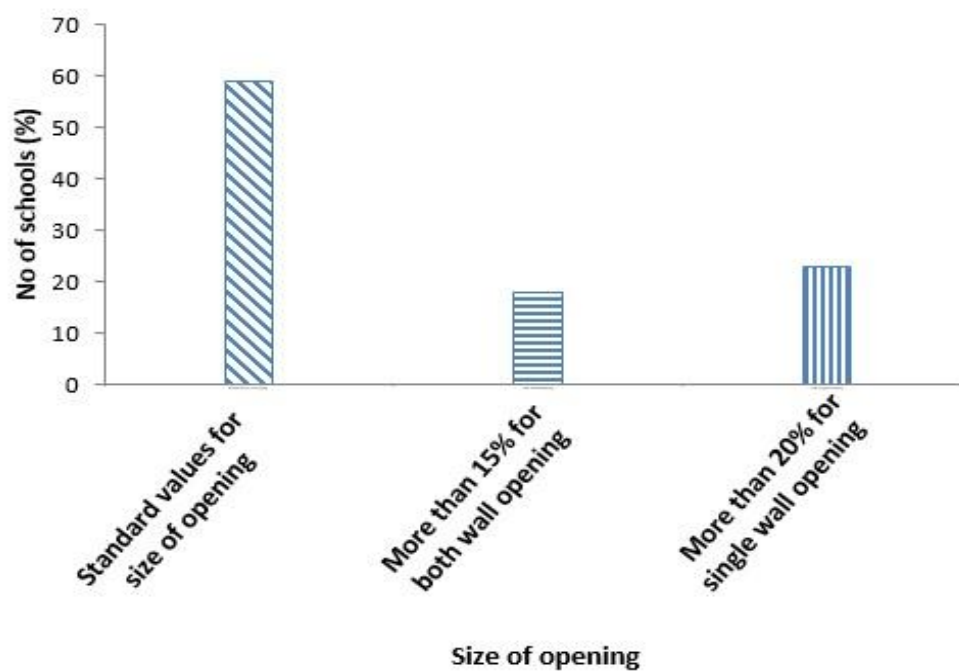
As we know that wall openings have great influence on functioning of the building. Hence the openings were determined against standard safe values according to cl. 4.5.4 of IS 8827:1978. The result showed that 40% of the building openings were not as per the specifications. This could be attributed to improper planning before construction.

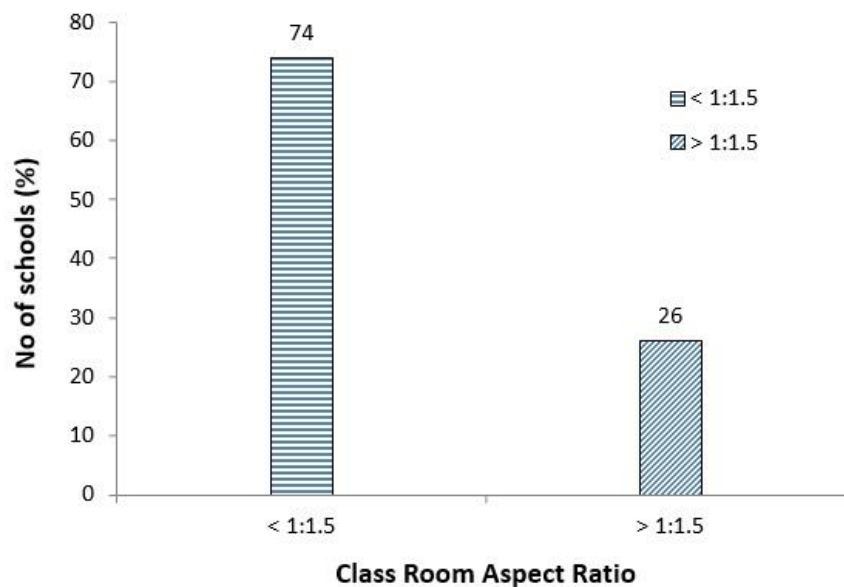
The dimensions of class rooms were surveyed to find out the aspect ratio (too long or too wide classrooms are not recommended as per cl. 4.5.2 of IS 8827:1978). From the survey data, it was found that 74% of school buildings have classrooms less than aspect ratio of 1:1.5, whereas the rest are not as per codal provisions. It is due to improper planning before construction.

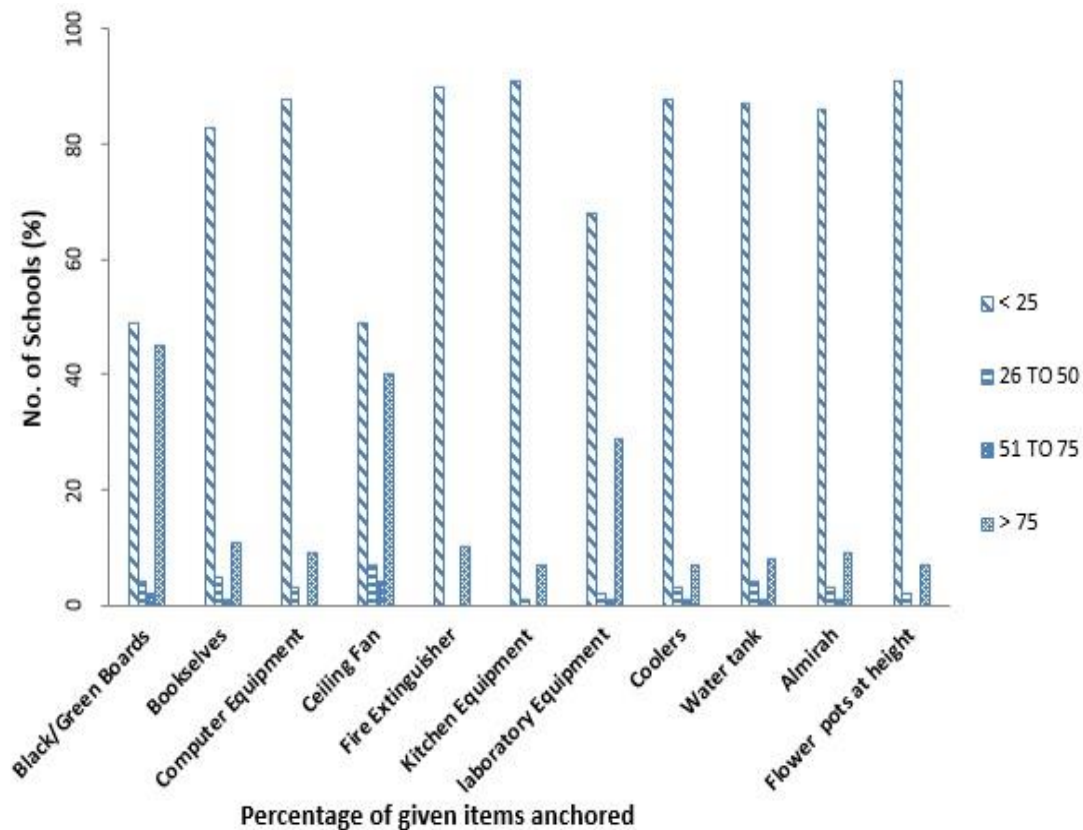
The underwritten non-structural items were surveyed to check the anchorage of the items to the wall/floor as non-anchored items gets damaged during earthquake. From the survey it was found that most buildings have less than 25% non-structural items anchored; hence items like black board, computer equipment, ceiling fan, laboratory equipment, cooler, water tank flower posts are likely to fall and get damaged during earthquake. Therefore the non-structural items are recommended to be anchored to avoid post-earthquake damage expenses.

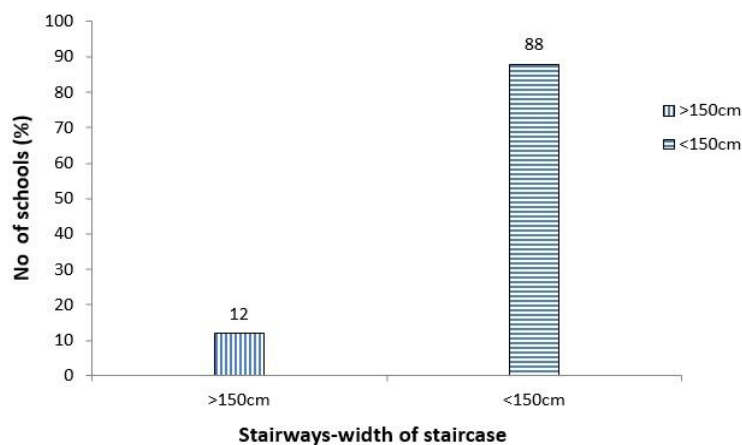
The width of staircases were surveyed to find out whether the stair cases are more than 1.5 meter wide to avoid stampede during hazard as per cl. 9.2.5 of IS 14435:2013. From the survey data, it came out that only 12% buildings have staircase wider than 1.5 meter, rest have narrower staircase. Thus the staircase width are highly deficient with respect to the provisions for fire safety in educational institutions.

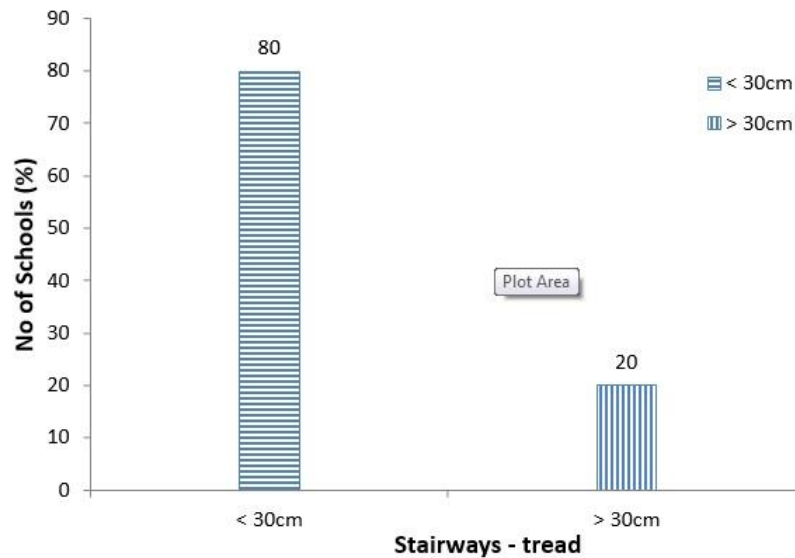
According to IS code, a minimum of 30cm tread is required as per cl. 9.2.6 of IS 14435:2013. From the survey, 80% buildings have tread shorter than 30 cm, whereas only 20% building blocks satisfy the codal provisions for fire safety in educational institutions.

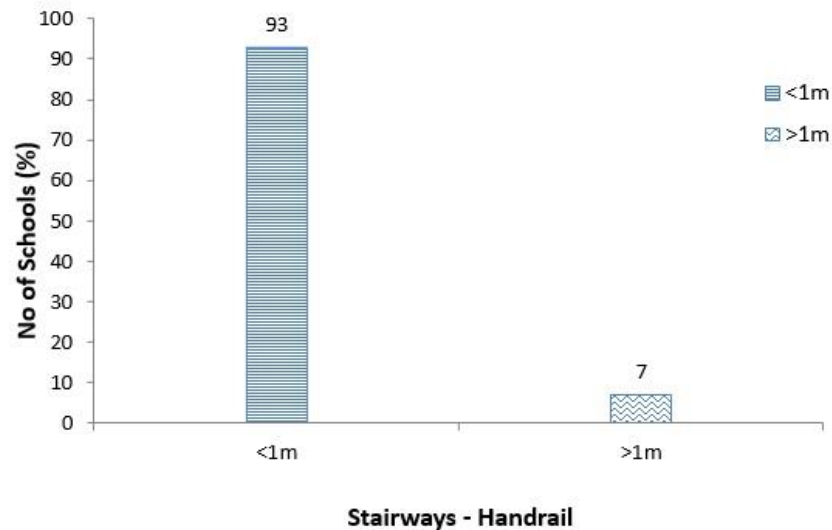
The handrail of stairways was surveyed against a height of 1 meter. From the survey it was found that 93% school buildings have stairways having handrail shorter than 1 meter, whereas only 7% buildings have handrails higher than 1 m. Hence it can be concluded that the stairways do not have proper height of handrails.

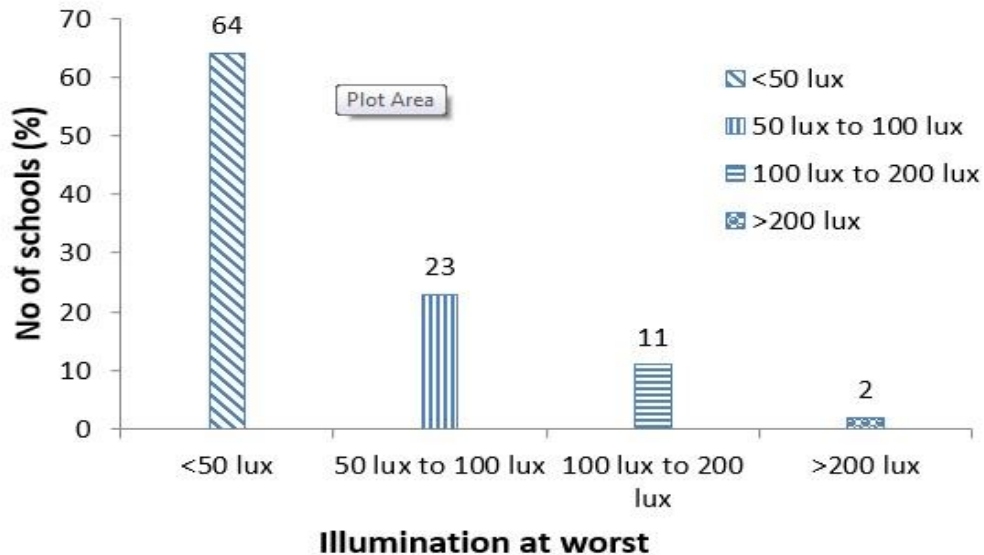
The classrooms were also checked for illumination at worst, which was checked against the minimum requirement of illumination of 150 lux according to codal provisions. From the survey, it can be concluded that about 87% schools have classrooms less than 100 lux illumination, which is a big issue about comfort of students during classes.

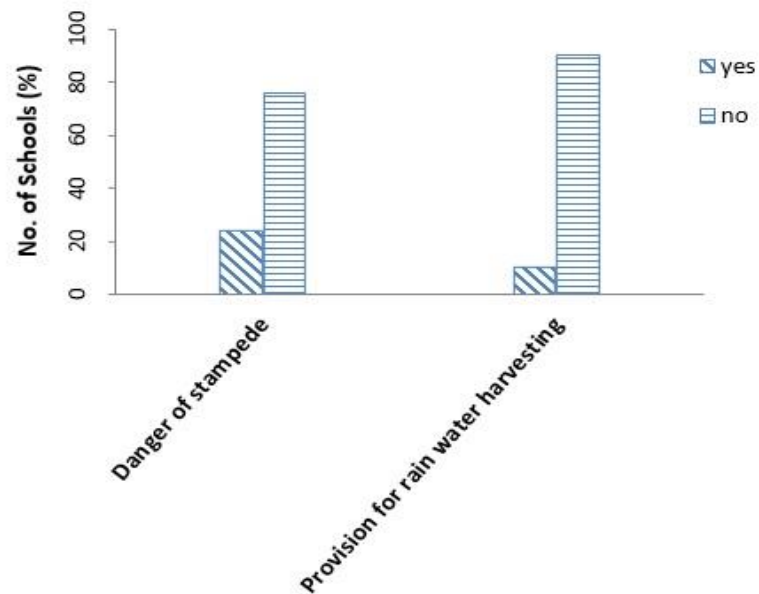
The following parameters were surveyed in school buildings. It has been found that 20% buildings has danger of stampede, due to non-coverage of staircase from top; whereas in 90% buildings provision for rain water harvesting is not present.
